### Inspection Report

#### Minerals Regulatory Program

**Mine Name:** Giles Pit  
**Operator Name:** W. W. Clyde

**Permit number:** M0130009  
**Inspection Date:** October 30, 2006  
**Time:** 4:15-4:45 PM

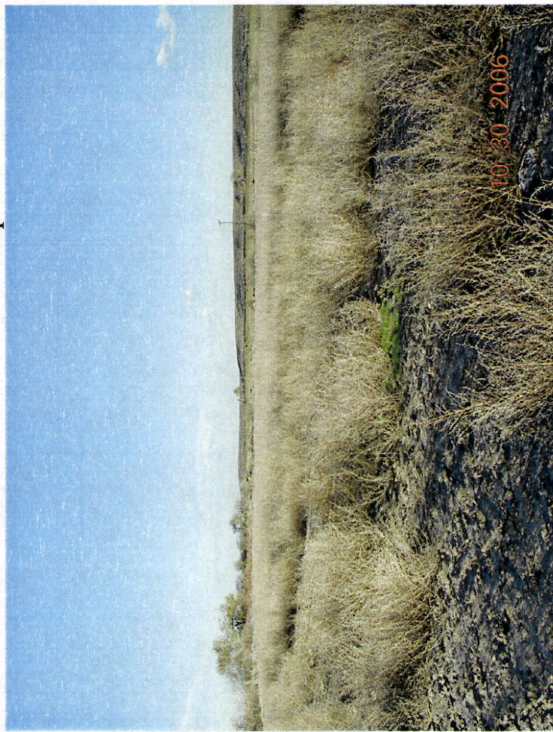
Photo 1. An overview of part of the area.

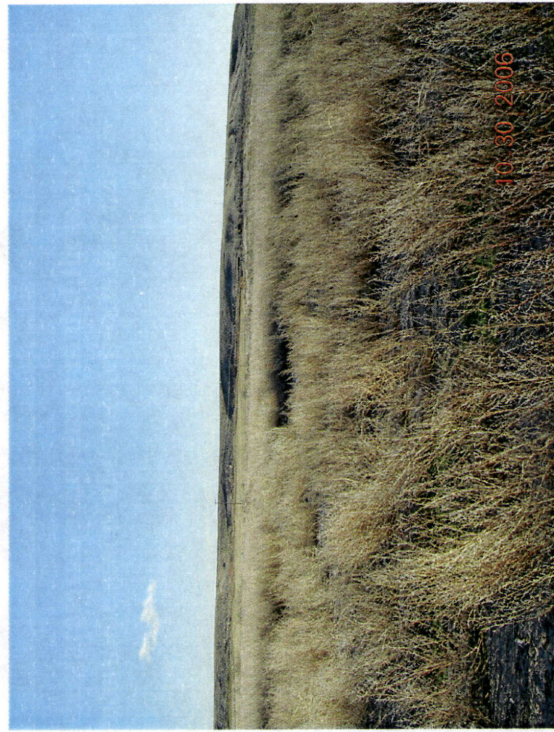
Photo 2. Another view.

Nearly all of the vegetation is *Kochia scoparia*, also known as kochia or summer cypress. I found one patch of cheatgrass, but I could find no desirable vegetation. I made no attempt to measure vegetation cover.

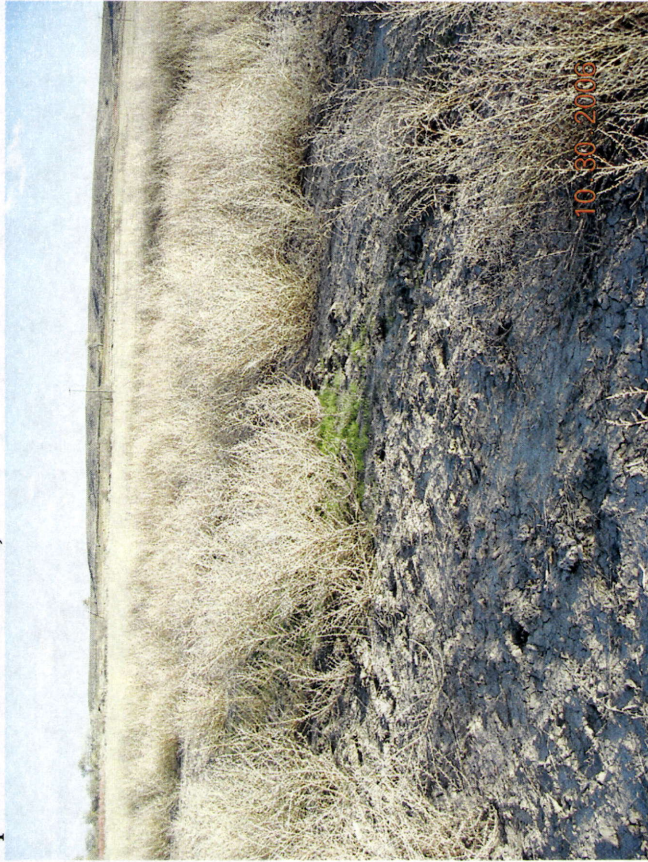
Photo 3. Note the cheatgrass near the center of the photo. As far as I could determine, the rest of the vegetation is *Kochia scoparia*.

Because of the condition on the revegetation variance, i.e. that the Division would inspect the site during the winter to ensure it is still being used to feed cattle, the Division needs to do one more inspection and verify this condition is being met. If so, the surety can be released.
